Detecting an improperly-lubricated journal bearing in a centrifugal compressor (when your 'toolbox' isn't full)

by Karl Enge, P.E.

MMS Engineer
Machinery Management Services
Bently Nevada Corporation
karl.enge@bently.com

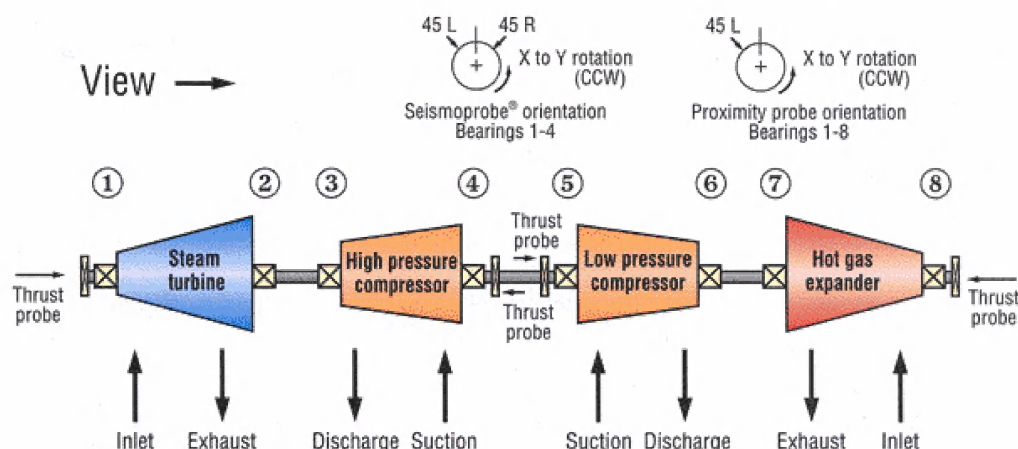
Figure 1
Machinery arrangement diagram.

per minute of air. It is rated at 6100 horsepower and includes a steam turbine driver, a high pressure (HP) and low pressure (LP) centrifugal air compressor, and a hot gas expander (Figure 1). The train operates at speeds near 10,600 rpm.

imity probes mounted at each radial and thrust bearing provided shaft vibration and position information (Figure 1). No Keyphasor® probe was installed to provide a 1X rotor phase reference. The signal from a proximity probe viewing a 60-tooth auxiliary drive gear (providing a 60X pulse) was directed to a tachometer in the control room.

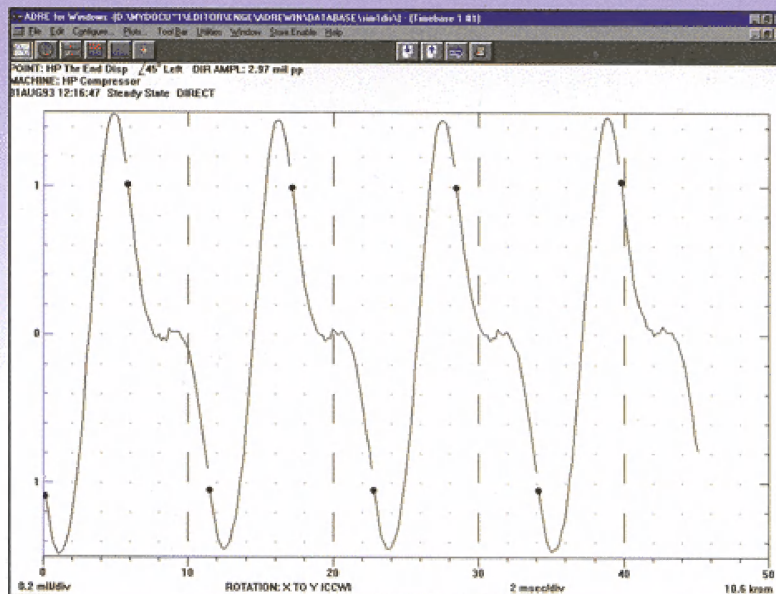
Figure 2
Steady state shaft direct timebase plot, HP compressor thrust end (Bearing #4).

Note the large difference between the shaft and bearing cap direct amplitudes. The shaft vibration waveform plot (Figure 2) shows a definite, repeatable pattern. The shaft vibration half spectrum plot (Figure 3) illustrates two predominant frequencies—a sub-synchronous component near 0.5X and the synchronous component at 1X. A component at 1.5X is also visible. The 0.5X, 1X, and 1.5X components in the bearing cap vibration half spectrum plot (Figure 4) occur at amplitudes close to the noise floor, indicating a low signal-to-noise ratio. It is clear from these plots that very little of the shaft vibration was being transmitted to the bearing caps. Data from the Seismoprobe transducers essentially contained no useful information.

Figure 2 shows that the Keyphasor marks on the waveform occur at the same location on each vibration cycle. Thus, the vibration was occurring at an integral sub-multiple of running speed; if the Keyphasor marks had drifted across the waveform pattern, then the vibration would not have been an integral submultiple. It was clear that the vibration was occurring at *exactly* 0.5X, rather than *about* 0.5X.

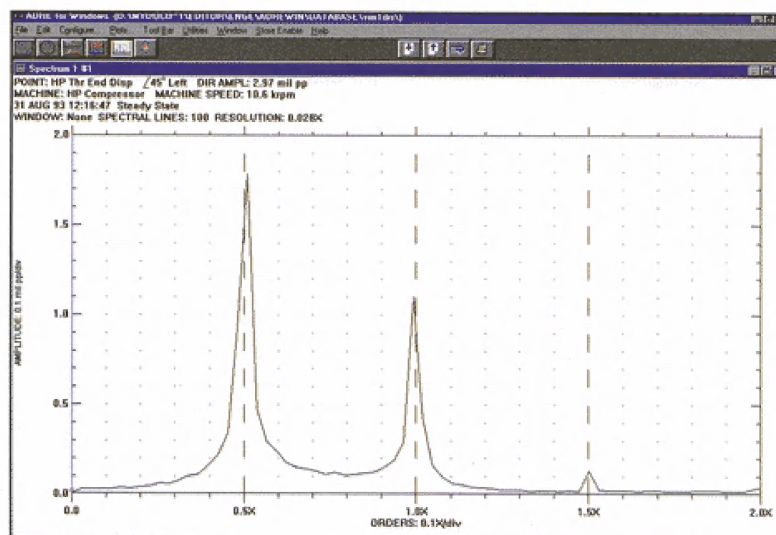
Figure 3
Steady state shaft half spectrum plot, HP compressor thrust end (Bearing #4).

Vibration about 0.5X would be a symptom of a fluid whirl or whip instability. Vibration at exactly 0.5X tends to be a symptom of a rub or a loose, oversize, or improperly lubricated bearing (although fluid whirl/whip still cannot be ruled out). Orbit and full spectrum plots would have been useful in this case by providing information on the direction of vibration relative to shaft rotation (forward/reverse precession). A rub can exhibit either forward or reverse precession (depending on its severity), while loose, oversize, or improperly lubricated bearings and fluid whirl/whip exhibit forward precession.

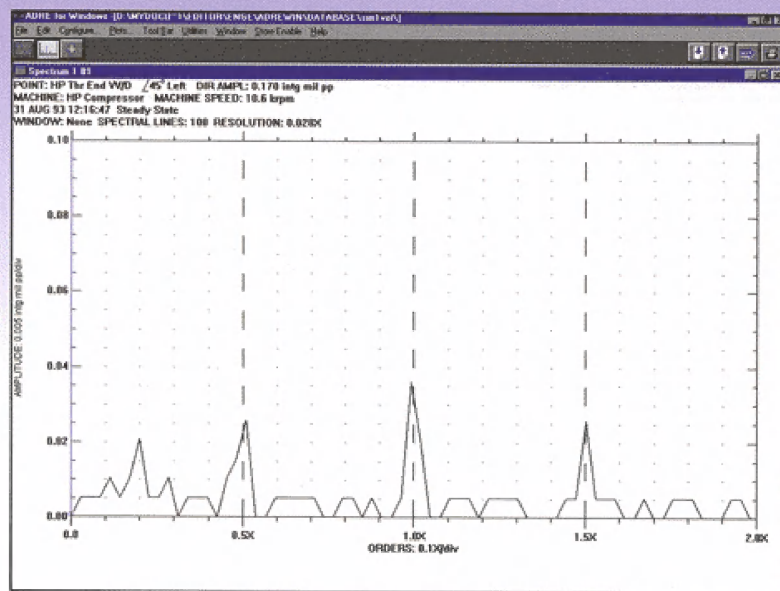
Figure 4

Steady state bearing cap half spectrum plot, HP compressor thrust end (Bearing #4).

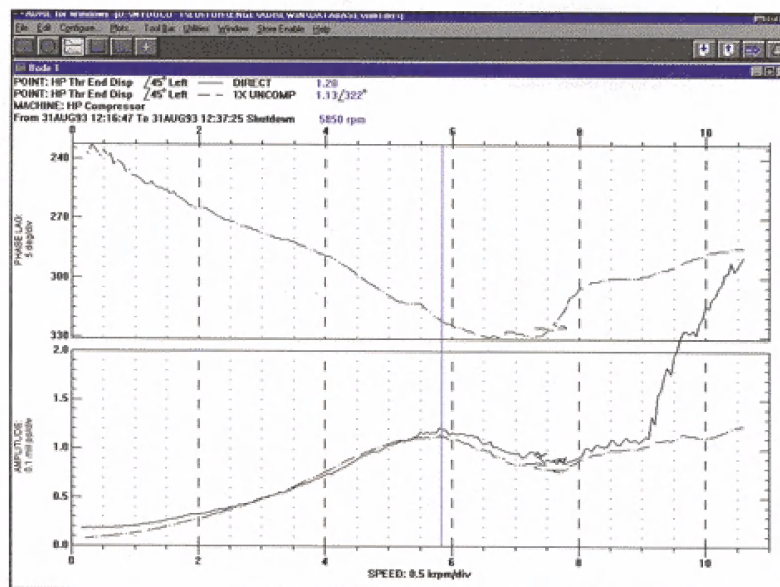
Figure 5

Initial shutdown Bode plot, HP compressor thrust end (Bearing #4).

- 1) The first balance resonance speed (critical speed) appeared to be at 5850 rpm (Figures 5 and 6). The design, or nameplate, balance resonance speed was reported to be at 6700 rpm. This reduction in the balance resonance speed was attributed to a decrease in the direct stiffness of the rotor/support system.

- 2) The 0.5X vibration dies out at speeds below 9150 rpm (Figures 5 and 7).

A rub could now be ruled out based on this information. A 0.5X rub occurs at machine speeds *above* twice the first balance resonance speed. In this case, a 0.5X rub might occur at speeds *above* 11,700 rpm; however, the 0.5X vibration was observed as low as 9150 rpm. In addition, rubs tend to *increase*, rather than *decrease*, the system's direct stiffness.

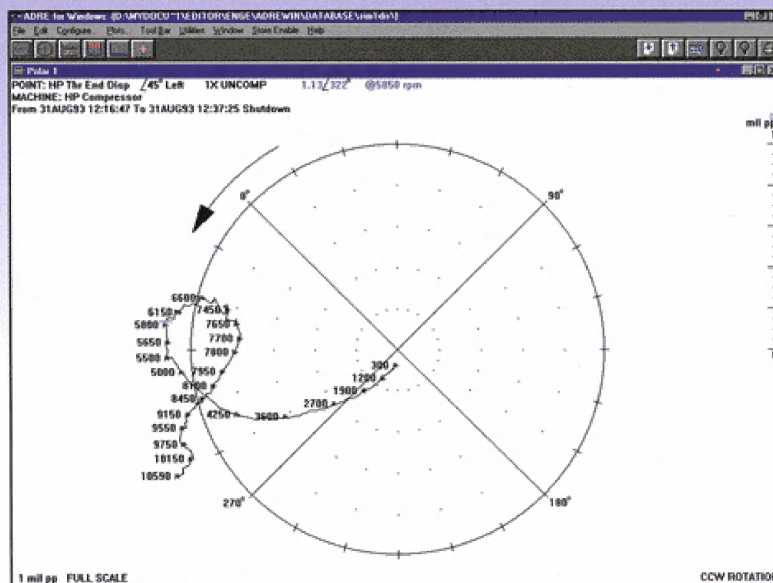
Figure 6
Initial shutdown polar plot, HP compressor thrust end (Bearing #4).

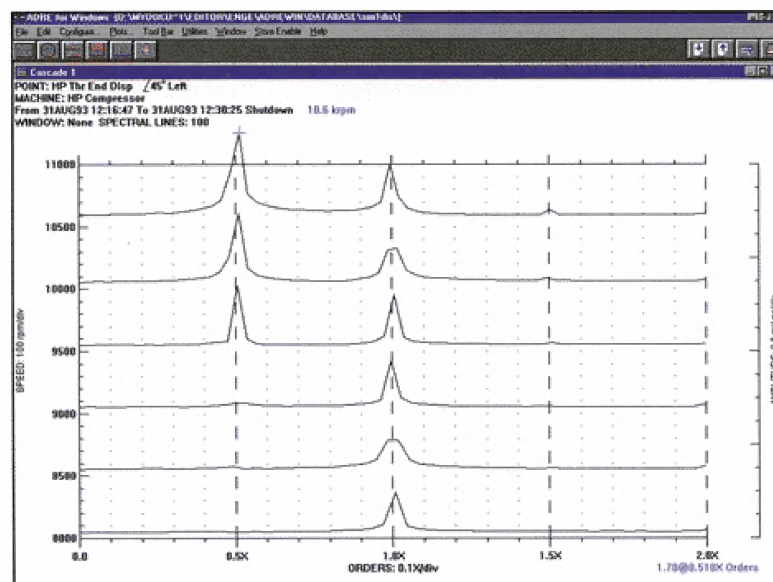
Figure 7
Initial shutdown half spectrum cascade plot, HP compressor thrust end (Bearing #4).

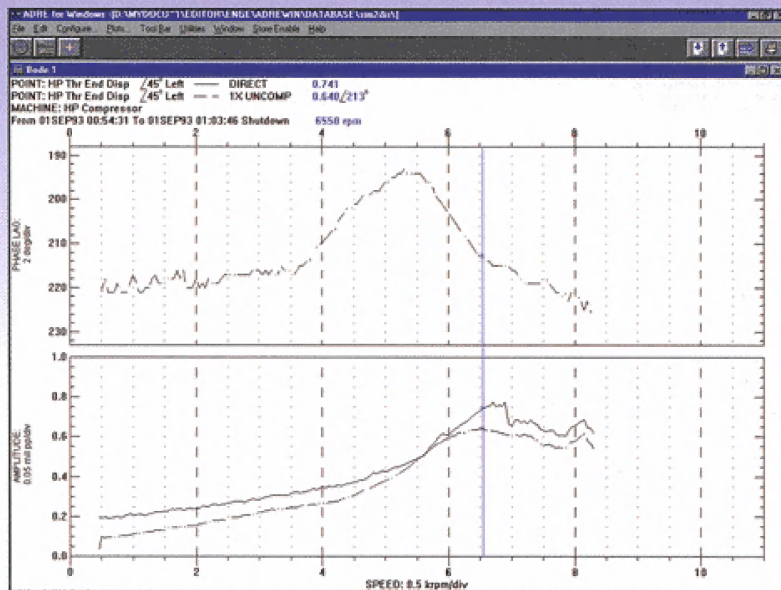
Figure 8

Shutdown code plot (8300 to 100 rpm), HP compressor thrust end (Bearing #4).

The compressor train was restarted and brought up to 8300 rpm, shut down, and restarted and brought up to 10,599 rpm. Figures 8 and 9 document the 8300 to 100 rpm shutdown; Figures 10 and 11 document the second restart from 7000 to 10,599 rpm. Please note that these plots are from two separate runs. The numerical values of the phase readings are not consistent between runs because the TK16 Multiplier/Divider selected a different phase reference point for each run. Phase data from Figures 8 and 9 should not be directly compared to phase data from Figures 10 and 11.

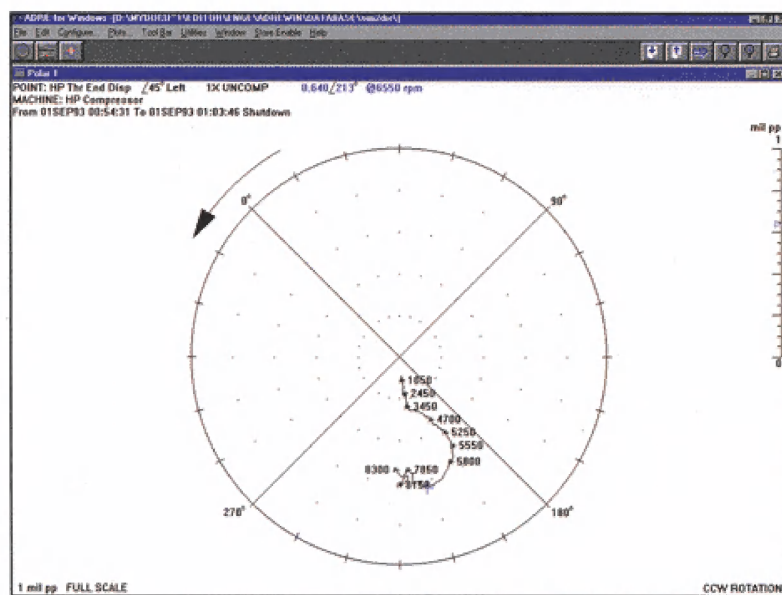
Figure 9

Shutdown polar plot (8300 to 100 rpm), HP compressor thrust end (Bearing #4).

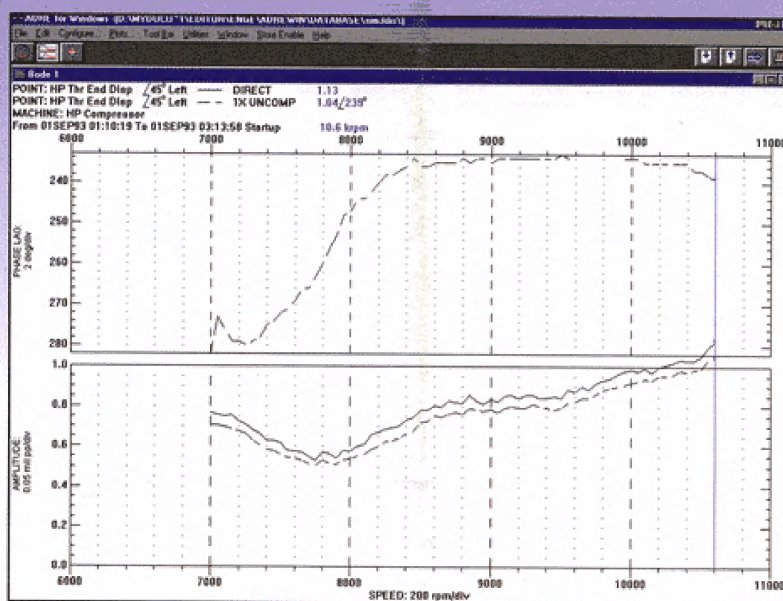
Figures 10 and 11 illustrate the decrease in the direct and 1X amplitudes which occurred above 9000 rpm after replacement of the bearing insert. There was no significant 0.5X vibration during this last restart. The final steady state shaft direct amplitudes at 10,595 rpm were 5.6 μ m (0.22 mil) pp at the non-thrust end (Bearing #3) and 30.0 μ m (1.18 mil) pp at the thrust end (Bearing #4). Figures 8 and 9 indicate that the first balance resonance speed shifted upwards, with the 1X uncompensated amplitude now peaking at 6550 rpm. The new balance resonance speed closely matched the nameplate balance resonance speed of 6700 rpm.

The observed phenomena could now be explained. It was likely the original, non-relieved bearing insert was improperly lubricated, which resulted in a fluid-induced instability. After it was replaced, the as-designed lubrication properties

were restored. The second bearing had less surface area compared to the first bearing (due to the oil groove). This increased bearing loading and, thus, the direct stiffness. The increased load would also tend to stabilize the bearing. Note that the original bearing insert had the same diametral clearance as the replacement bearing insert; it was not oversized.

Figure 10
Restart Bode plot (7000 to 10,599 rpm), HP compressor thrust end (Bearing #4).

The plain-bore bearing insert was found to be incorrectly manufactured. Correctly manufactured inserts have an oil groove in the center of the insert with an 0.003 inch greater diametral clearance. The bearing insert that was initially in place was found to have a center clearance identical to the edge

clearance; there was no oil groove. A correct bearing insert was located and installed.

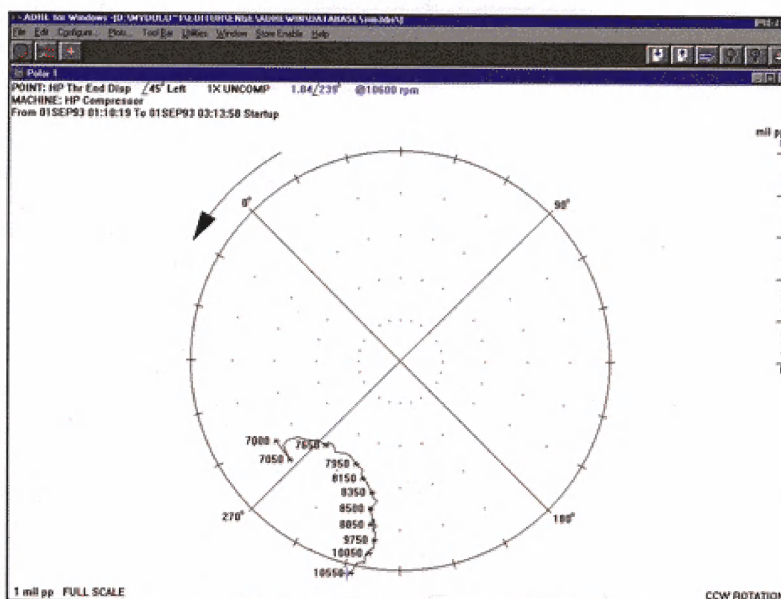
Figure 11
Restart polar plot (7000 to 10,599 rpm), HP compressor thrust end (Bearing #4).
